**HUMAN ENGINEERING EVALUATION  
OF THE  
HYPERBARIC RESEARCH FACILITY  
(PHASE 1)**

**J.I. Brady and M.D. Curley**

**Naval Medical Research Institute**

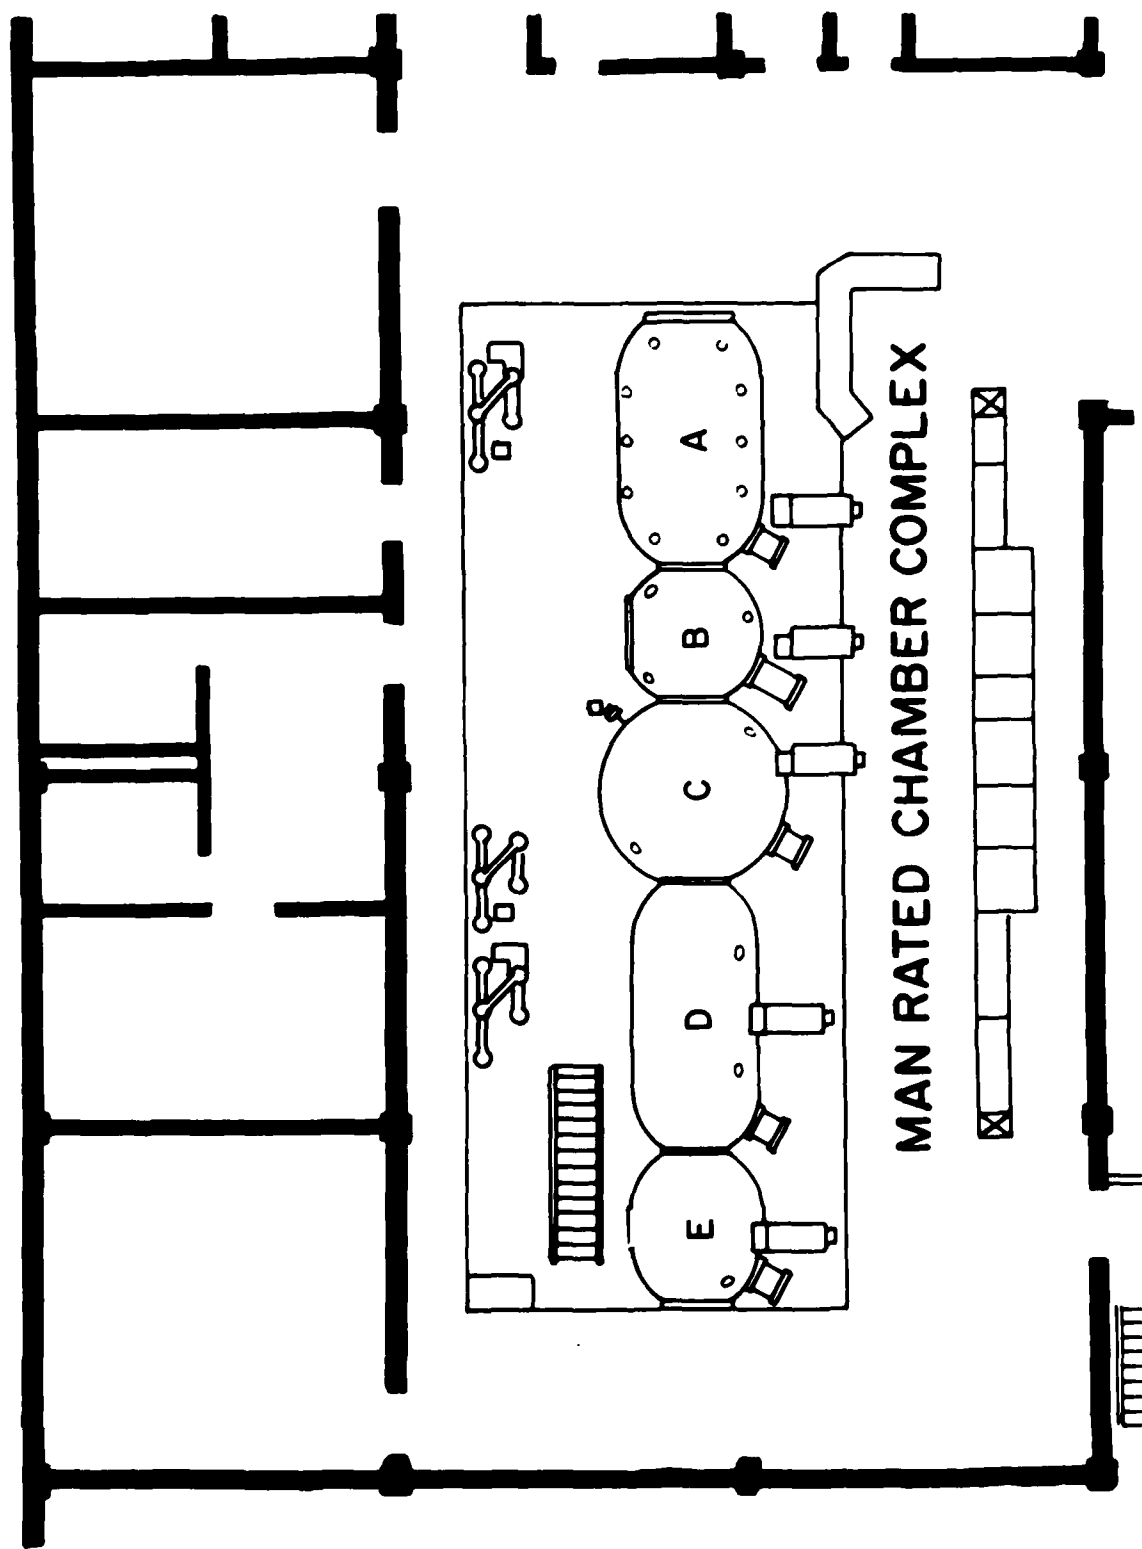
Fig. 1. The five chambers comprising the HRF saturation chamber complex.

- (1) To aid in location description and because it is consistent with the Navy's other shore-based deep diving saturation complex, the chambers should be identified by the letters A-E as indicated in Fig. 1. As will be seen in the upcoming recommendations for

control panel changes, this system lends itself readily to functional grouping techniques and color-coding. (Priority 2)

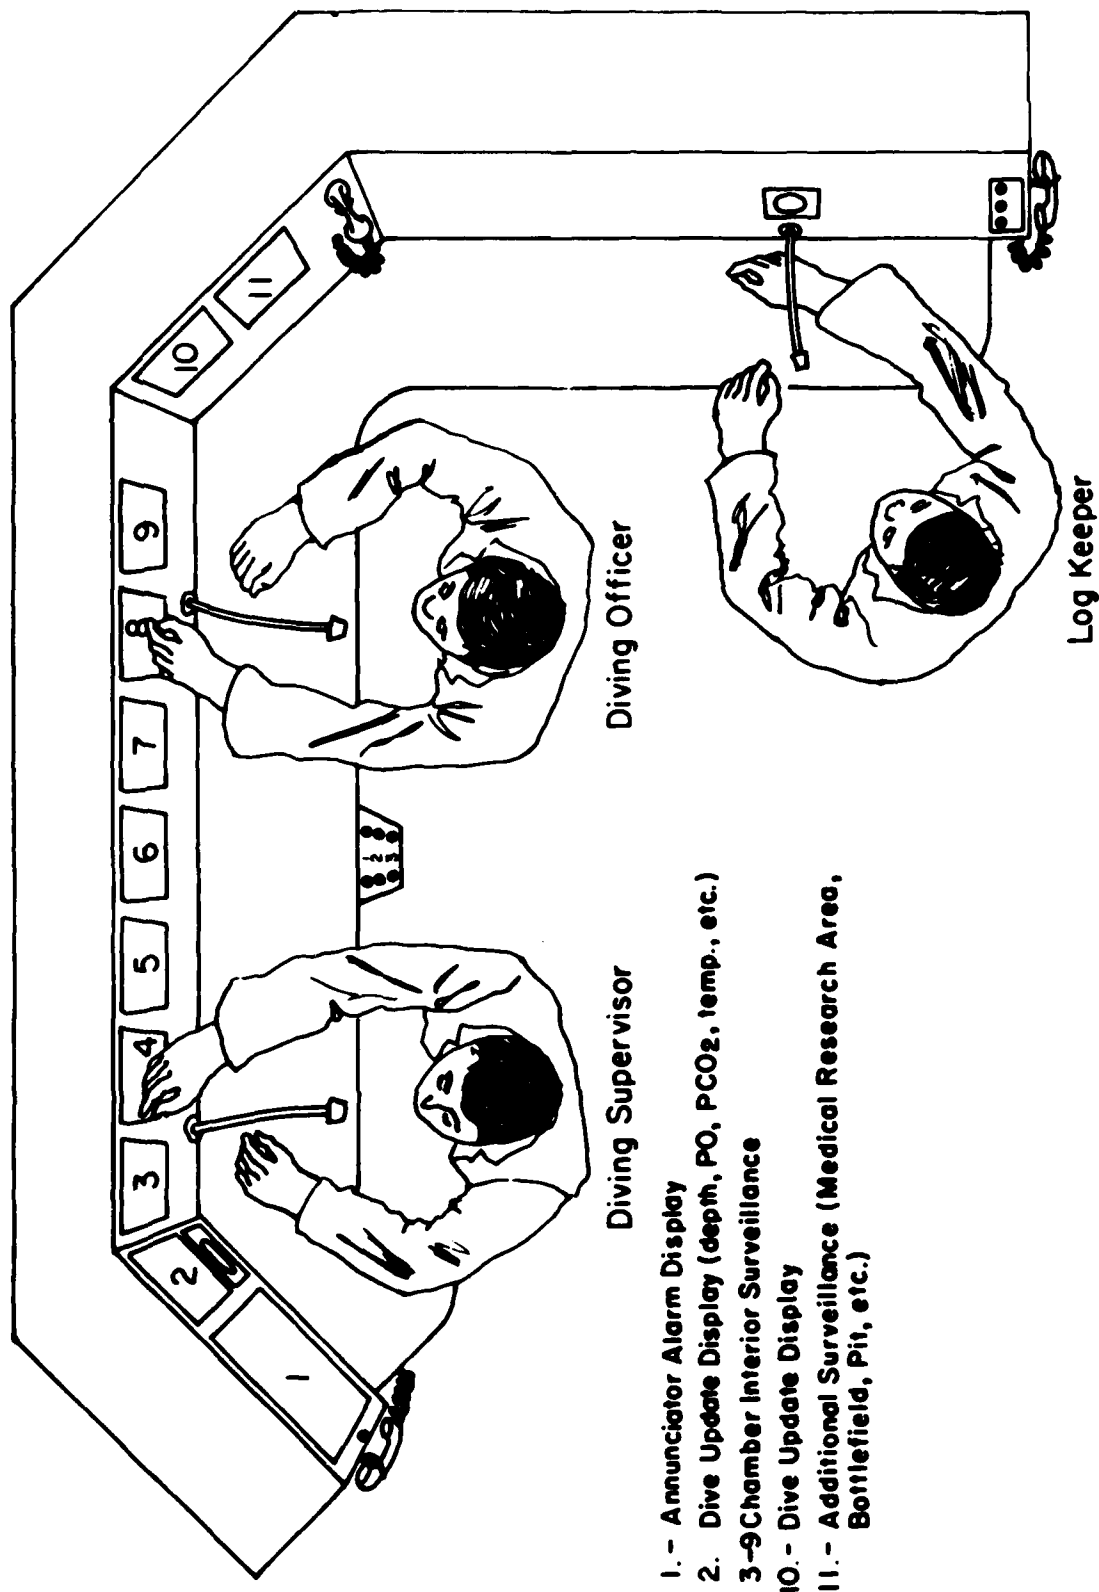
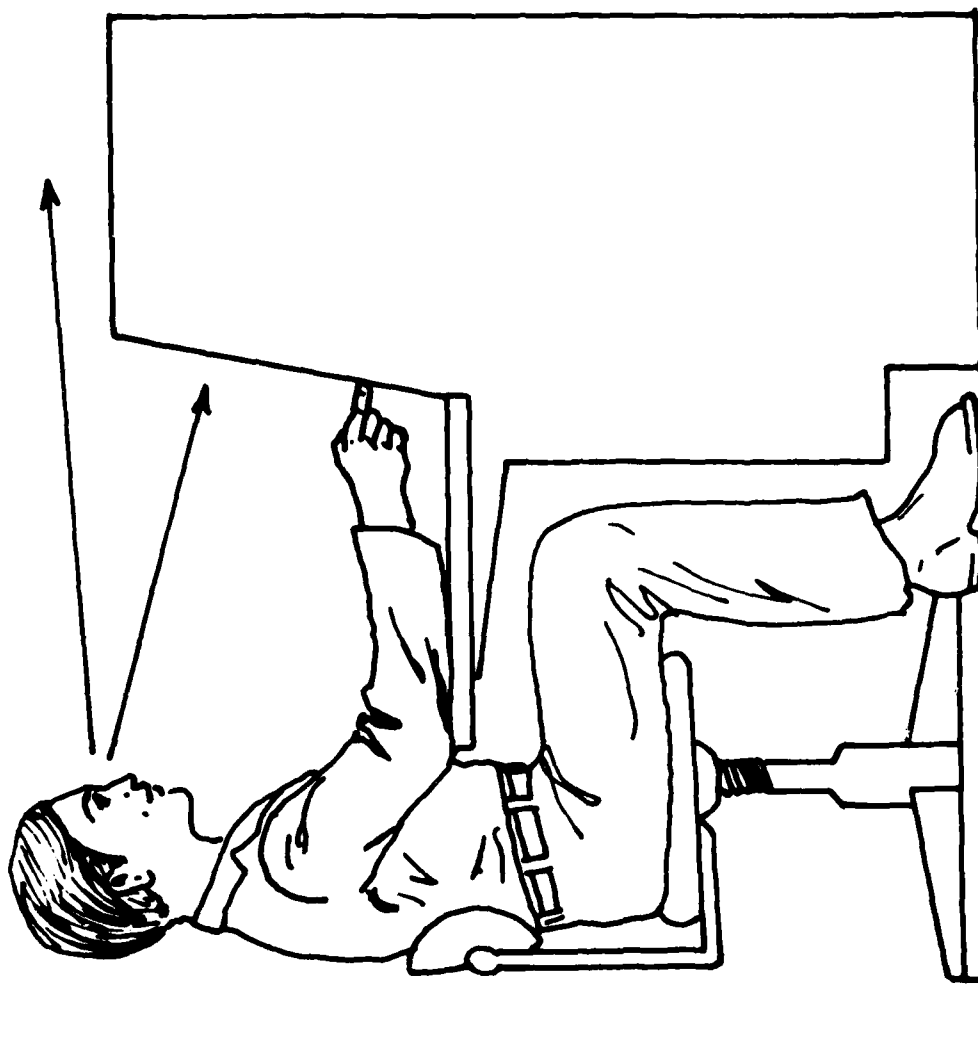
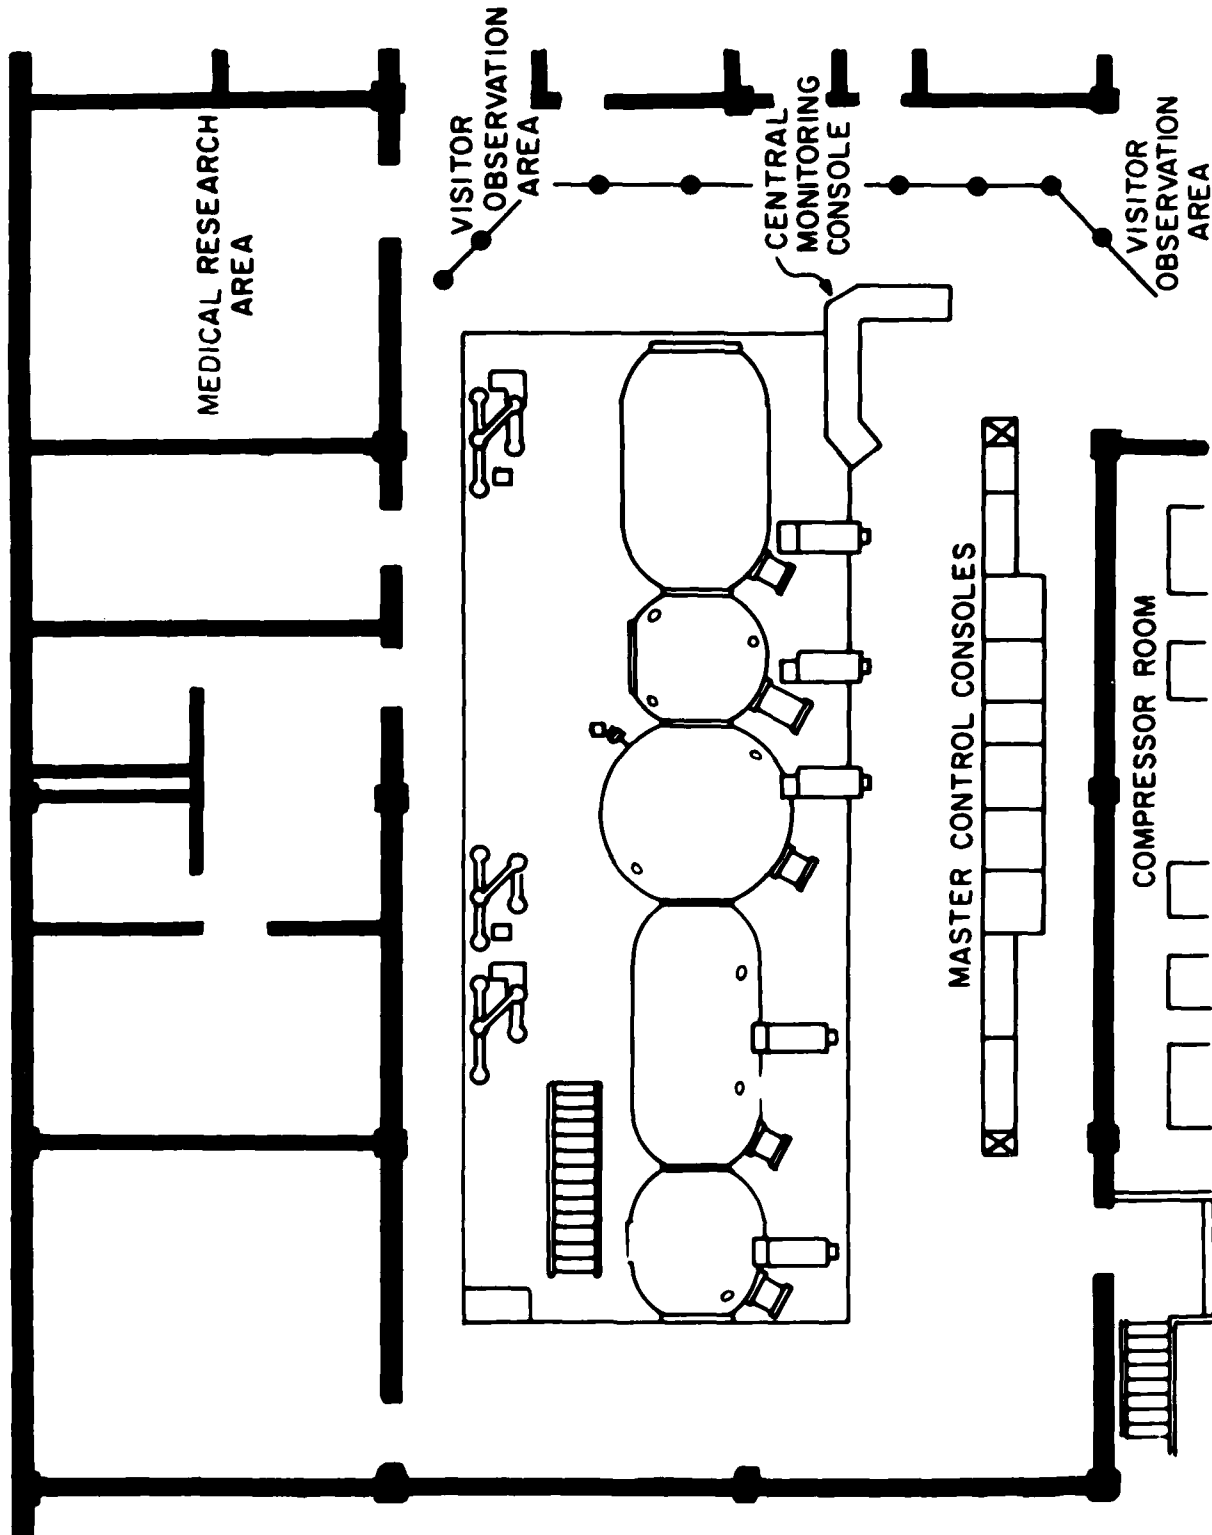
- (7) The present console design does not provide an adequate diving officer and diving supervisor watch station. Such a watch station should function primarily as a central monitoring location. Figures 5 and 6 show a recommended layout for this watch station. Figure 7 indicates the suggested location for the station. This location provides a complete view of the master control consoles, as well as easy access to the medical research area and visitor observation areas.

Fig. 5. Possible layout for a central monitoring console to accommodate the diving officer, diving supervisor, and log keeper.

Fig. 6. Side view of a central monitoring console for a seated operator.

Fig. 7. Recommended location of central monitoring console.

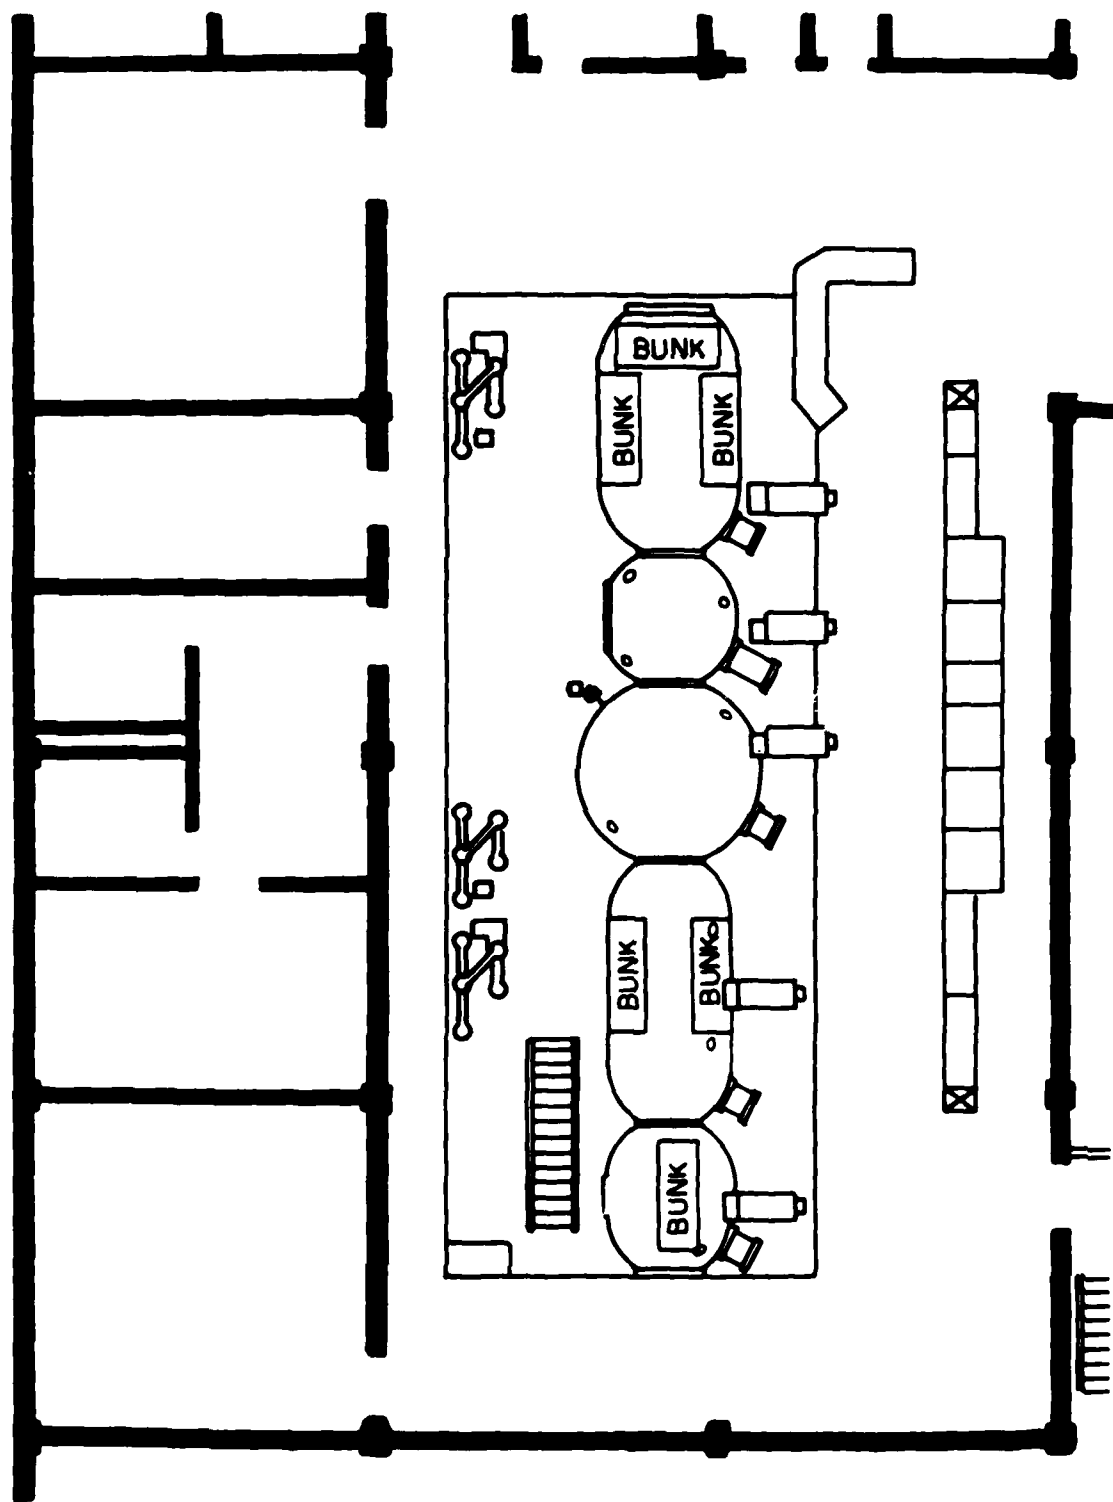
Fig. 24. Recommended bunk arrangement when entire complex is at depth.

- (38) The removable bunks in C chamber (Fig. 23) should be moved to permanent locations in other chambers. See Fig. 24 for recommended locations. (Priority 2)

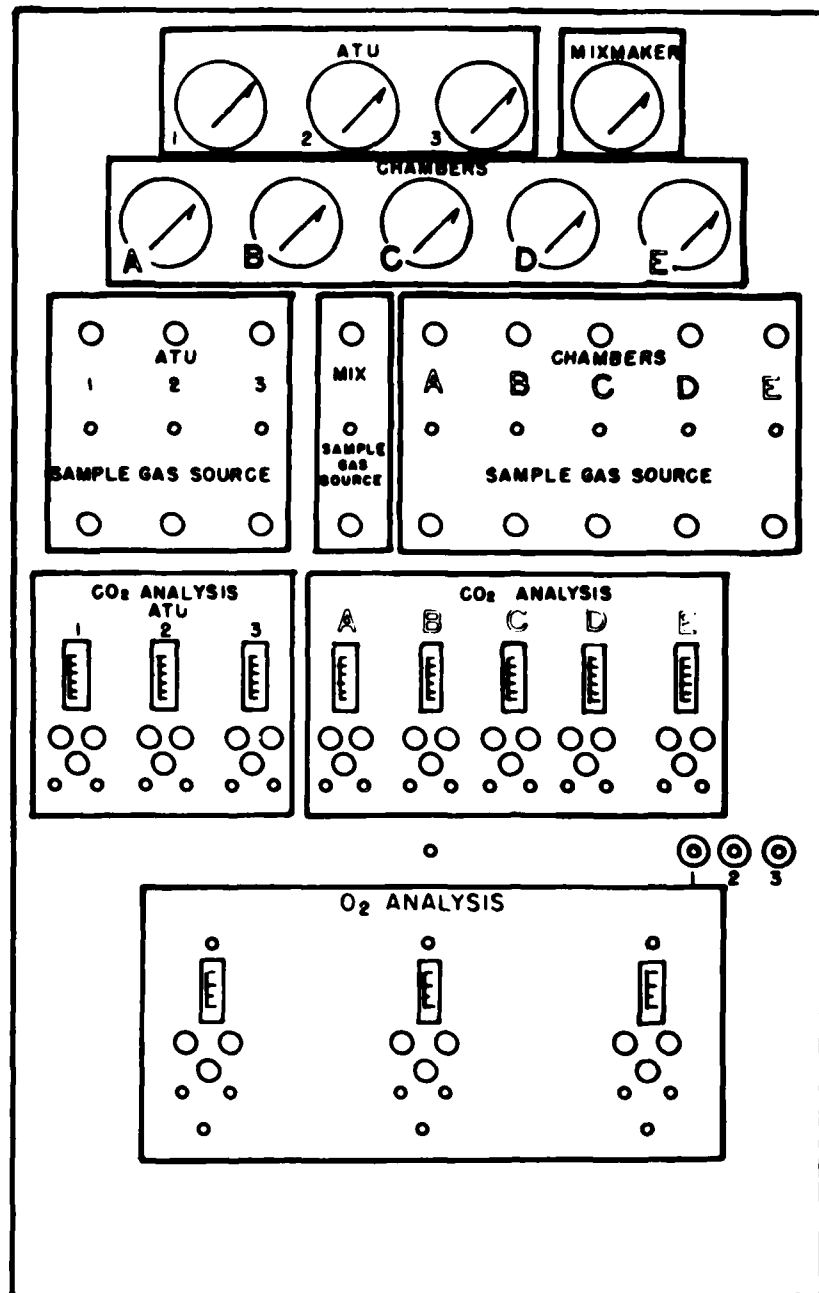
Fig. 29. A proposed layout for the gas analysis patch panel. Gauges and valves are labeled in a simple, easily understandable manner and components of similar function are grouped together graphically and color-coded.

operator. Figure 29 shows the recommended changes. This layout does not require the movement or alteration of any of the hardware (although several more efficient designs could be devised). It simply employs functional grouping and color coding. This design should improve operator recognition and readability while reducing errors. (Priority 2)

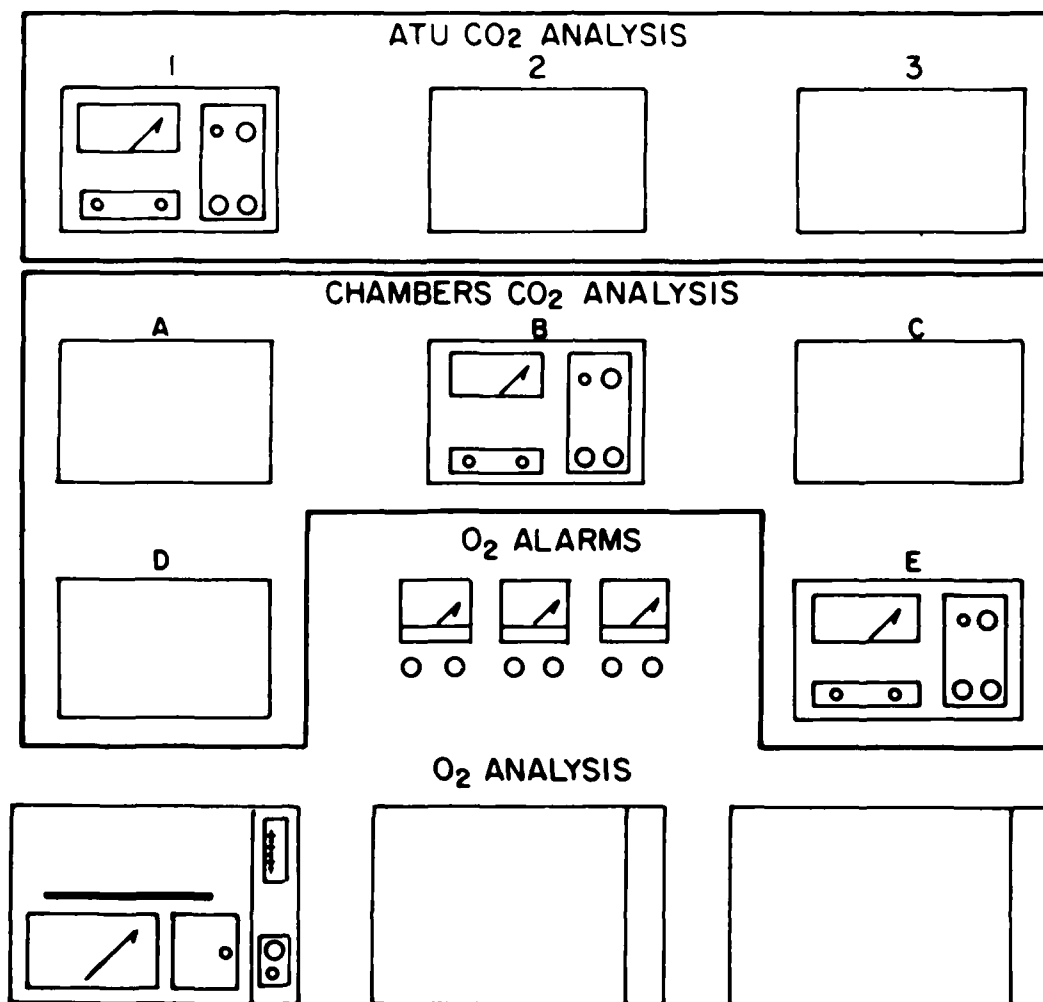
Fig. 31. A proposed layout for the gas analysis instrumentation panel. Again, functional grouping, color-coding, and large simplistic labeling have been employed to improve readability and decrease recognition time.

- (53) Figure 30 shows the present gas analysis instrumentation panel. The recommended changes are similar to those above (see Fig. 31). (Priority 2)
- (54) Figure 8 showed the face of a local control panel. Greater clarity of function can be obtained by concise gas paths and simple noncoded labeling. The recommended scheme is shown in Fig. 32. (Priority 2)

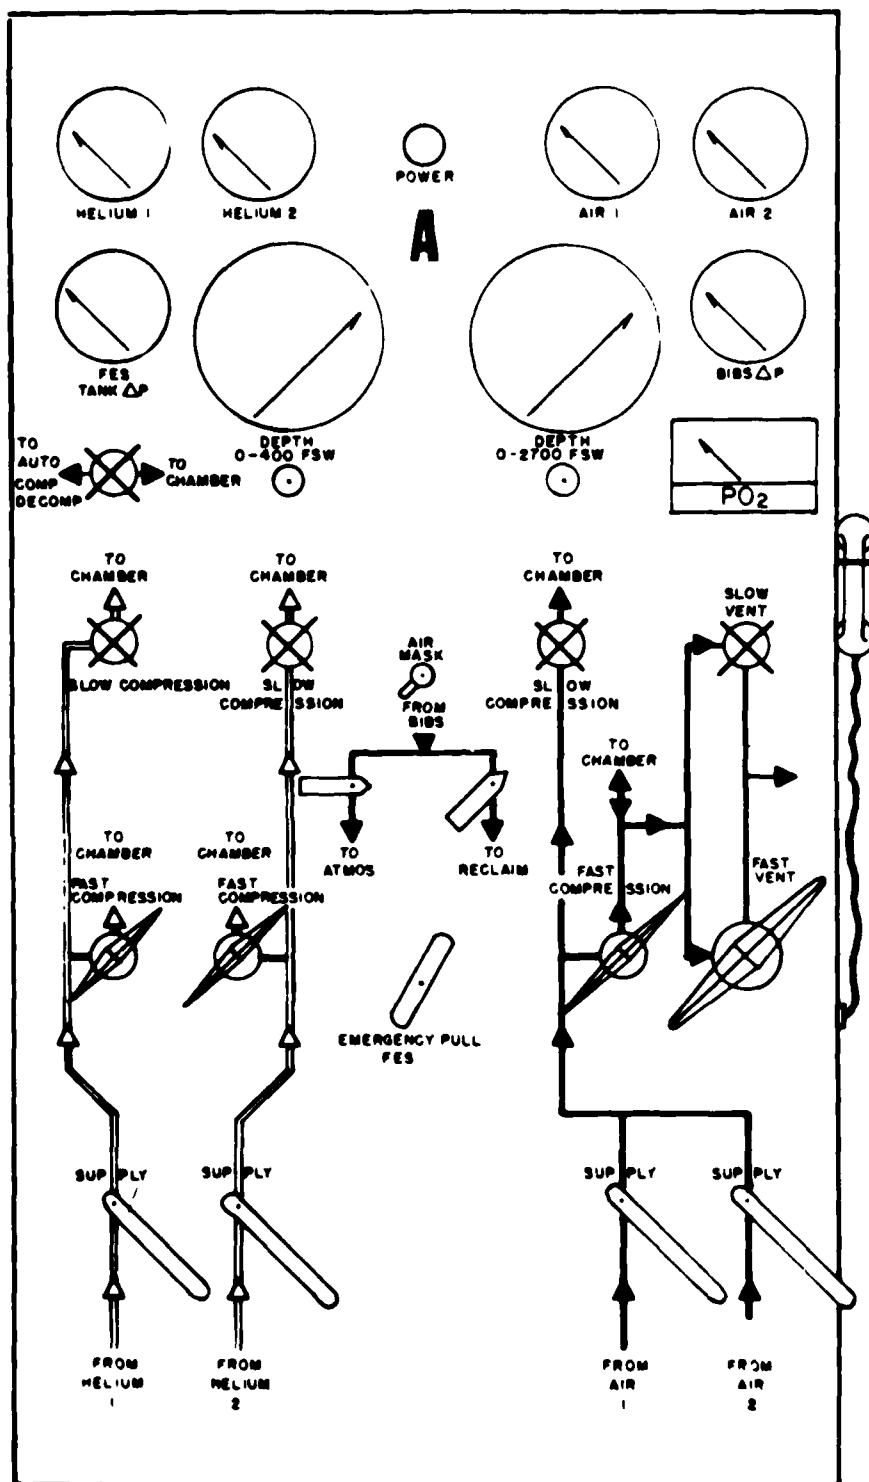
Fig. 32. A proposed layout for the local control panel. Gas paths would be appropriately color-coded.

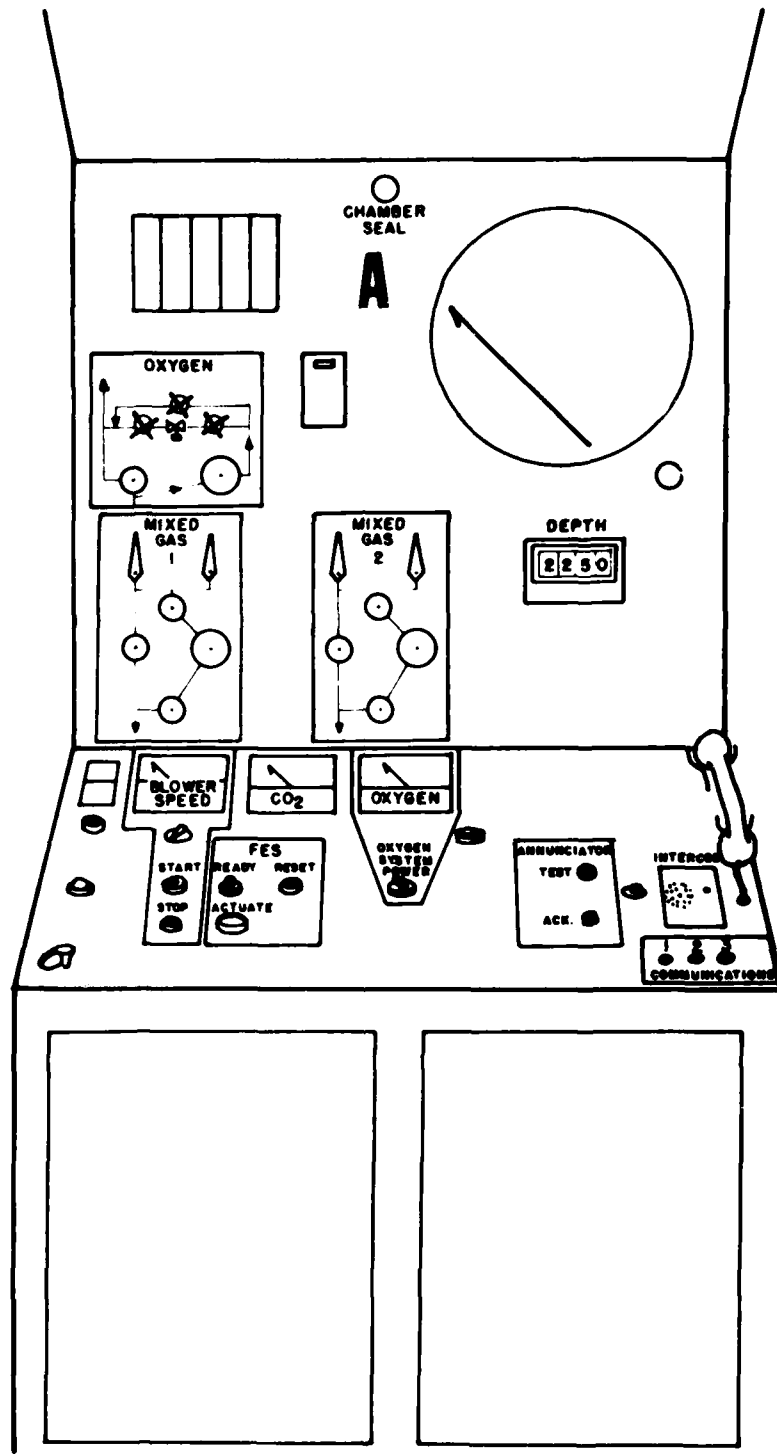
Fig. 34. A proposed layout for the operating panels.

- (56) The operating panels (Fig. 33) can be similarly modified to improve their organization in a meaningful and logical manner. Figure 34 shows a layout for recommended changes. (Priority 2)

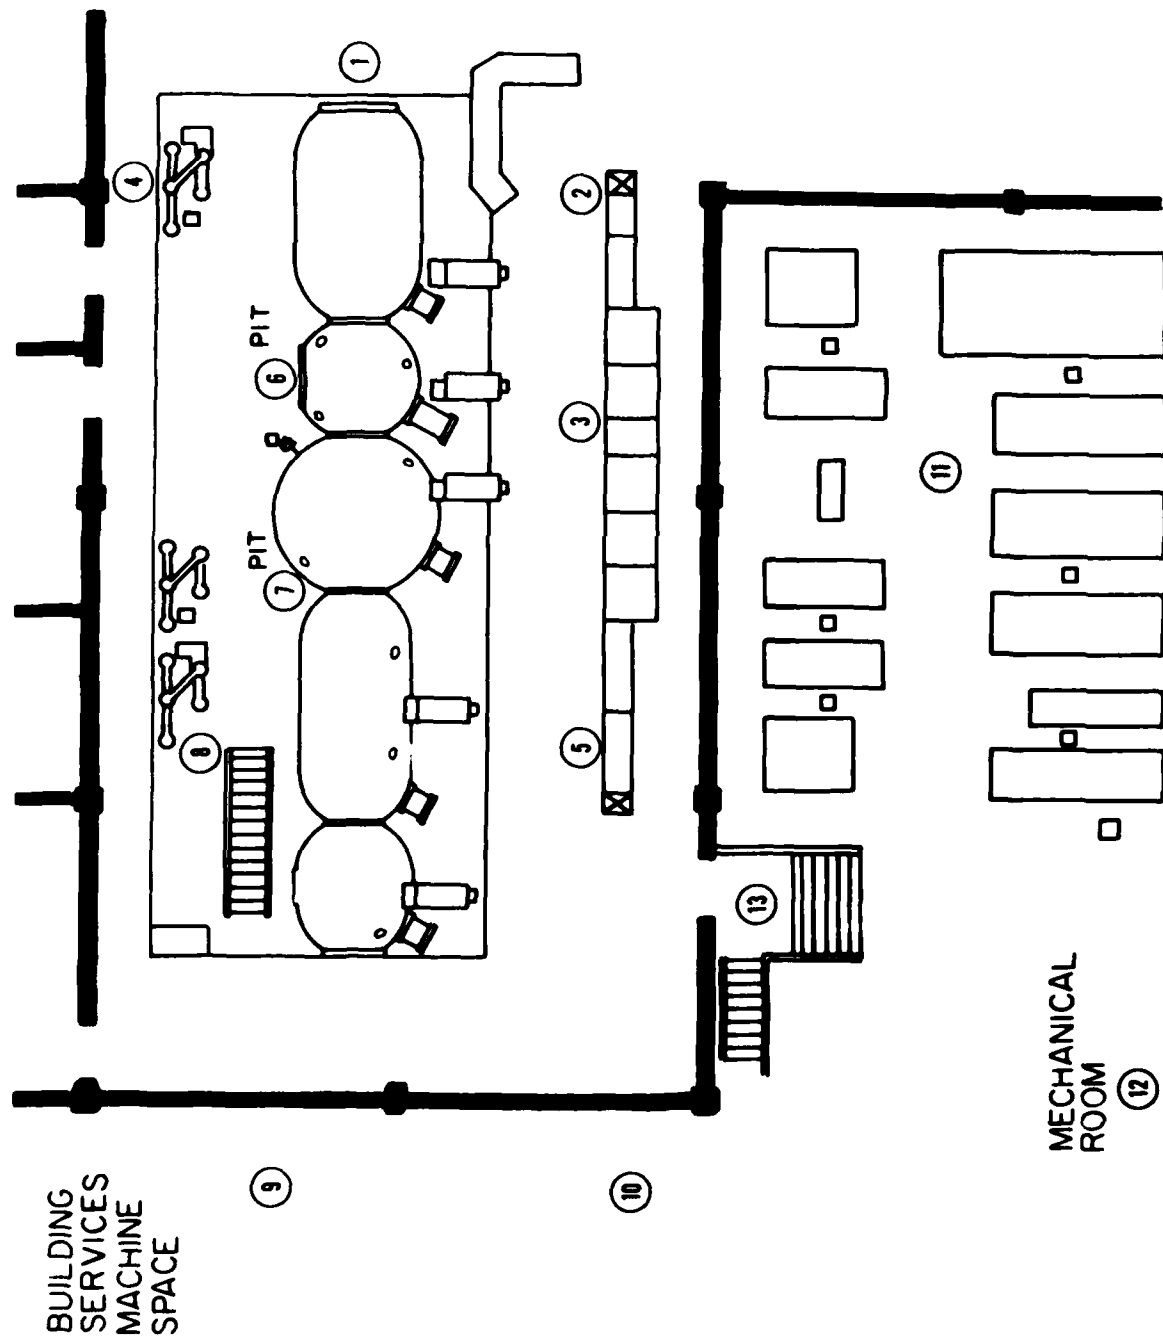
- (1) As previously mentioned, recorded noise levels in several places within the HRF approach the upper limit of the OSHA standards for an 8 h exposure. Figure 36 indicates the 13 locations where sound levels were periodically recorded. The circled numbers rank the locations from the lowest noise level [1] to the highest [13]. The lower noise levels which occur in the vicinity of the operating panels are still high enough to fatigue operators exposed to them for lengthy periods of time and to reduce communication efficiency between members of the diving watch as well as between the diving watch and divers within the chamber. The major contributors to the noise levels in the immediate chamber

Fig. 36. The 13 locations in which noise levels were measured. The higher the number, the higher the recorded noise level.

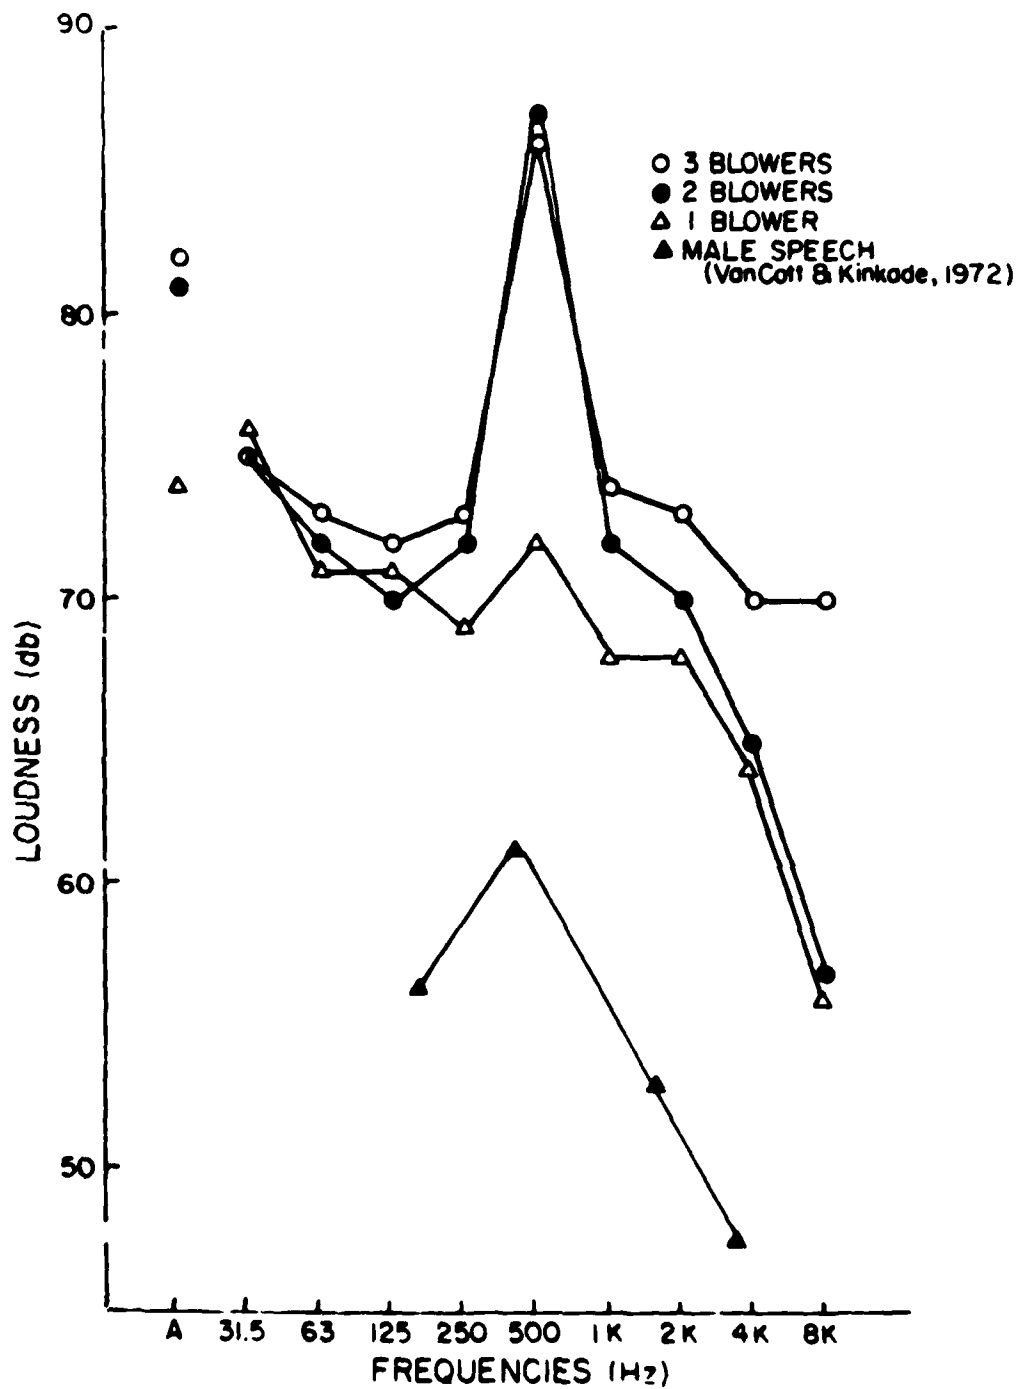
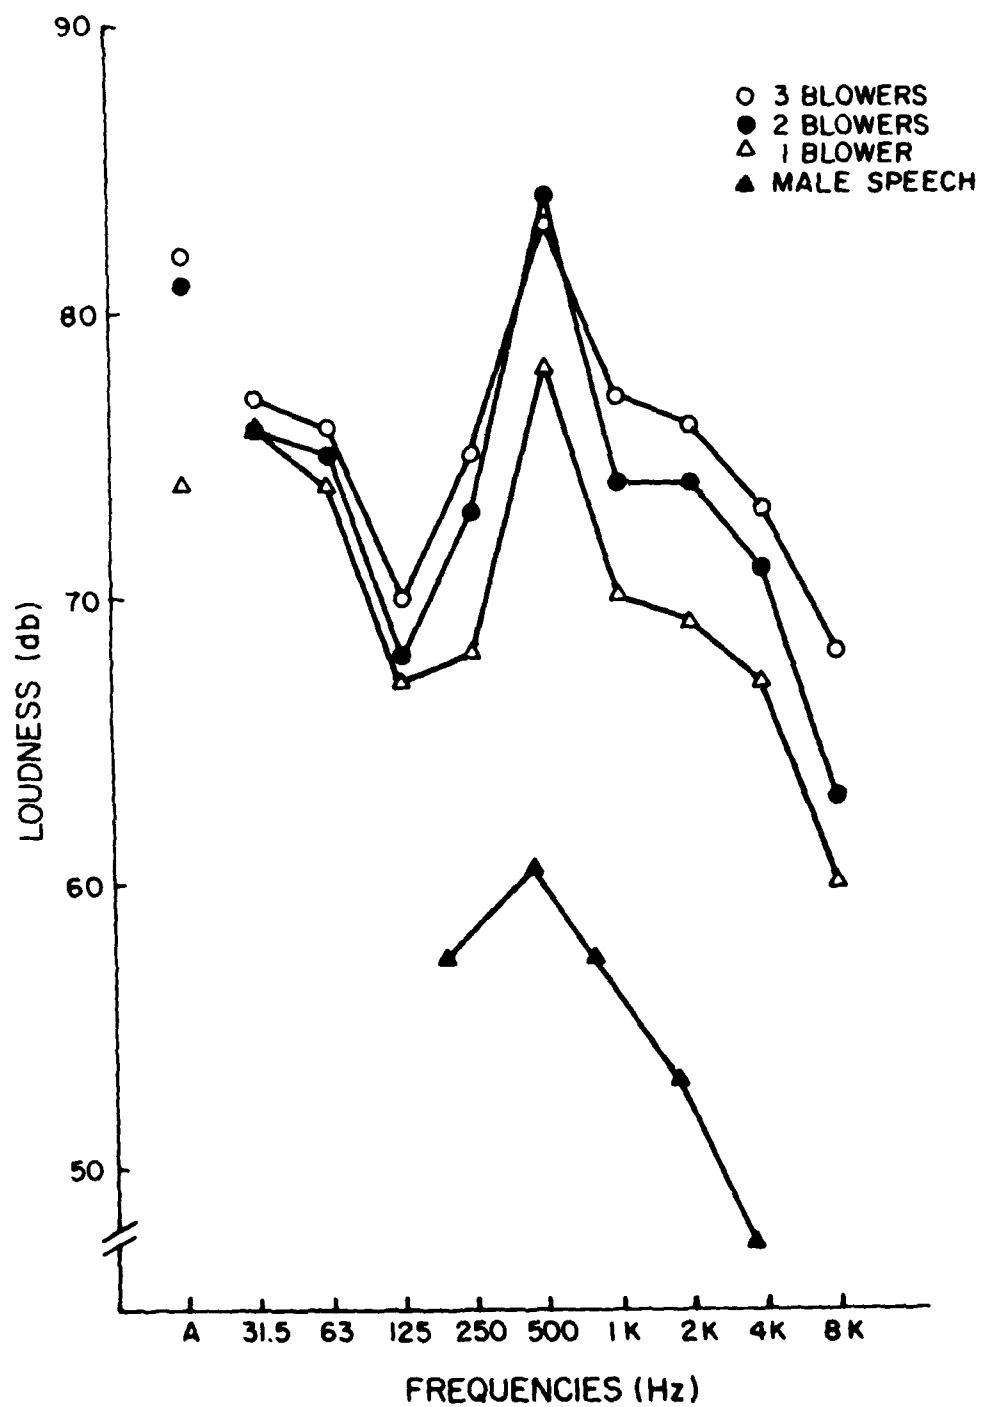
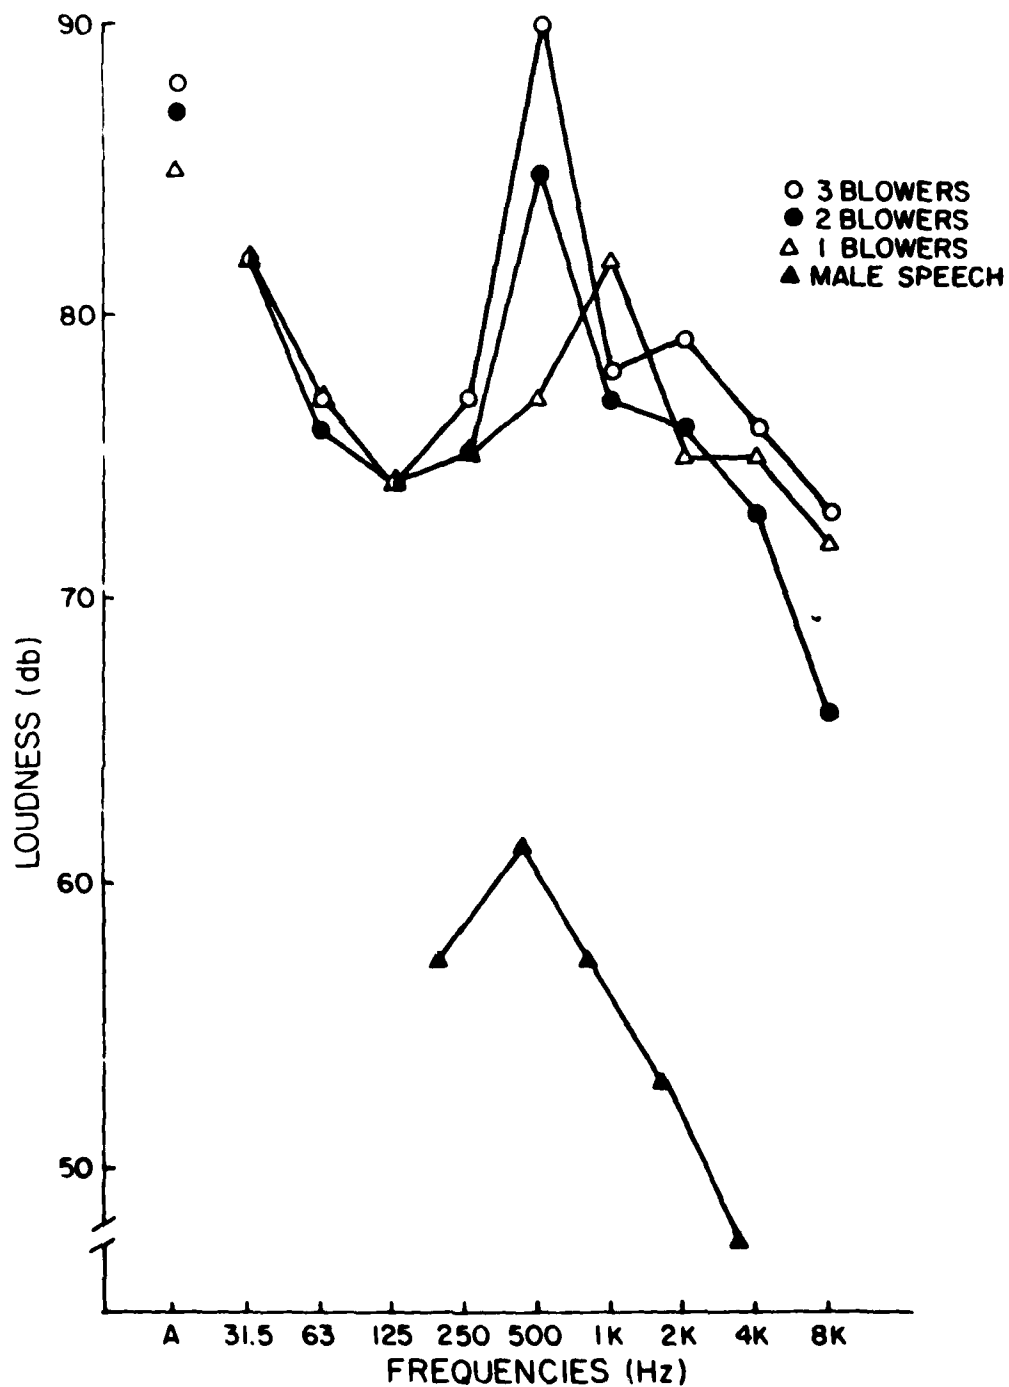
area are the building air conditioning system and the motors, which drive the life-support blowers for the chambers. Octave band analysis of the noise spectrum associated with the building air conditioning system and 1, 2, or 3 ACS blowers is shown for three locations in the immediate chamber area (Fig. 37, 38, and 39). As can be seen, the peak noise levels produced by these machines, fall in the same frequency range as the peak levels in male speech at conversational intensities. Thus, ear protectors to attenuate the peak noise frequencies will also reduce an individual's ability to understand human speech, since they share the same peak frequencies. Consequently, personnel-worn ear protectors, while reducing the danger of hearing damage due to the high noise intensity, will reduce communication capabilities markedly. Anything less than optimal communication conditions in the operator control areas of the hyperbaric saturation diving system is unacceptable. It is felt that the primary noise sources can and must be effectively attenuated at their sources. The highest noise levels (85-98 dB) were observed, not surprisingly, in the compressor room adjacent to the chamber area. A sound-protected office is already planned for personnel working in this area, but personnel should wear ear plugs (or similar equipment) when working around the compressors and machinery.

Fig. 27. Octave band analysis of the noise spectrum associated with the building air conditioning system and 1, 2, or 3 ACS blowers recorded at master console. Peak levels in male speech at conversational intensities are also provided.

Fig. 38. Octave band analysis of the noise at the A chamber ACS loop.

Fig. 39. Octave band analysis of the noise at the D chamber ACS loop.

(Priority 1)
